Advanced Composite Vertical Fin
for L-1011 Aircraft

*Design, Manufacture, and Test
(Executive Summary)*

A. C. Jackson

CONTRACT NAS1-14000
SEPTEMBER 1984

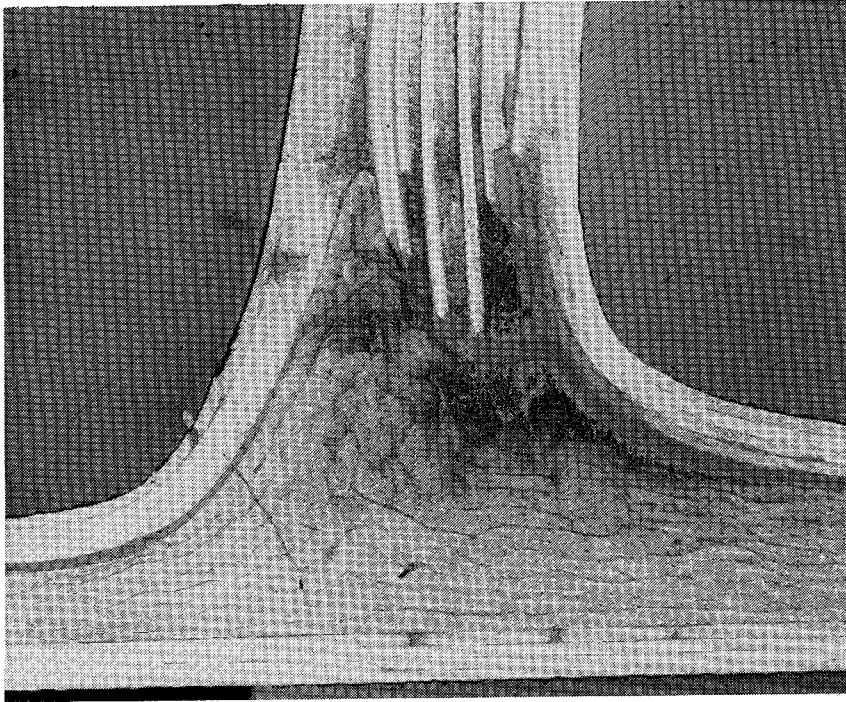
Figure 29. - Photomicrograph of section from GTA No. 1 front spar cap, right side at VSS 278.3.

The first static test resulted in an unexpected failure at 98 percent Design Ultimate Load (DUL). Following an investigation into the cause of the failure, a second ACVF (GTA No. 2) was reinforced and the test program continued. The following is an account of the failure analysis of GTA No. 1, reinforcement of GTA No. 2 and the subsequent testing of GTA No. 2.

As a result of the ground test some redesign would be necessary before the fin could be committed to production. A redesign of the spar would include taking all the web plies around into the cap, and the cap would be designed for specified out-of-plane loading. Figure 30 shows a schematic of the original cap and the redesigned cap. It is estimated that a redesign of the spars would add about 15 lbs. This would be due to thicker spar caps when all the web plies are continued into the cap flanges, the elimination of the lower six access holes in the front spar web and the replacement of the front

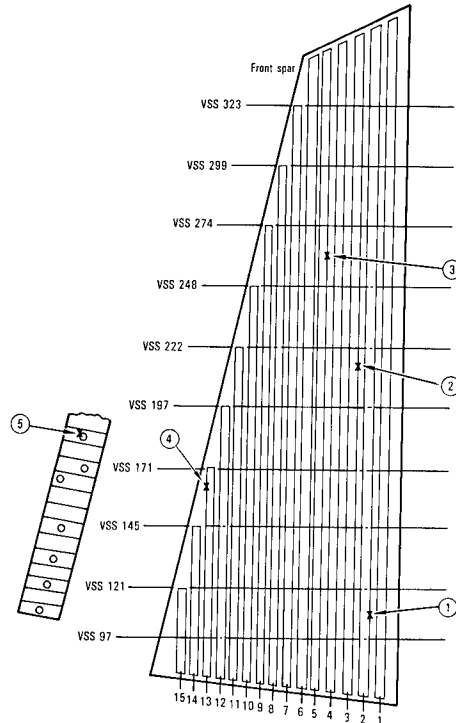
Figure 34. - Impact damage locations.

Impact No. 2 was in the 14-ply skin area. Four impacts were required to obtain visible damage. The first impact was at 13.33 ft-lb. Some damage was evident ultrasonically. A second impact at 8.64 ft-lb showed no evidence of change ultrasonically. A third impact, now back at 13.33 ft-lb, gave no visible damage but increased the damage area determined ultrasonically. A fourth impact was made, but at an energy level of 18.95 ft-lb. Visible penetration through the thickness occurred.

Impact No. 3 was in the 10-ply skin area. This area was impacted at 13.33 ft-lb also. One impact caused visible surface damage.

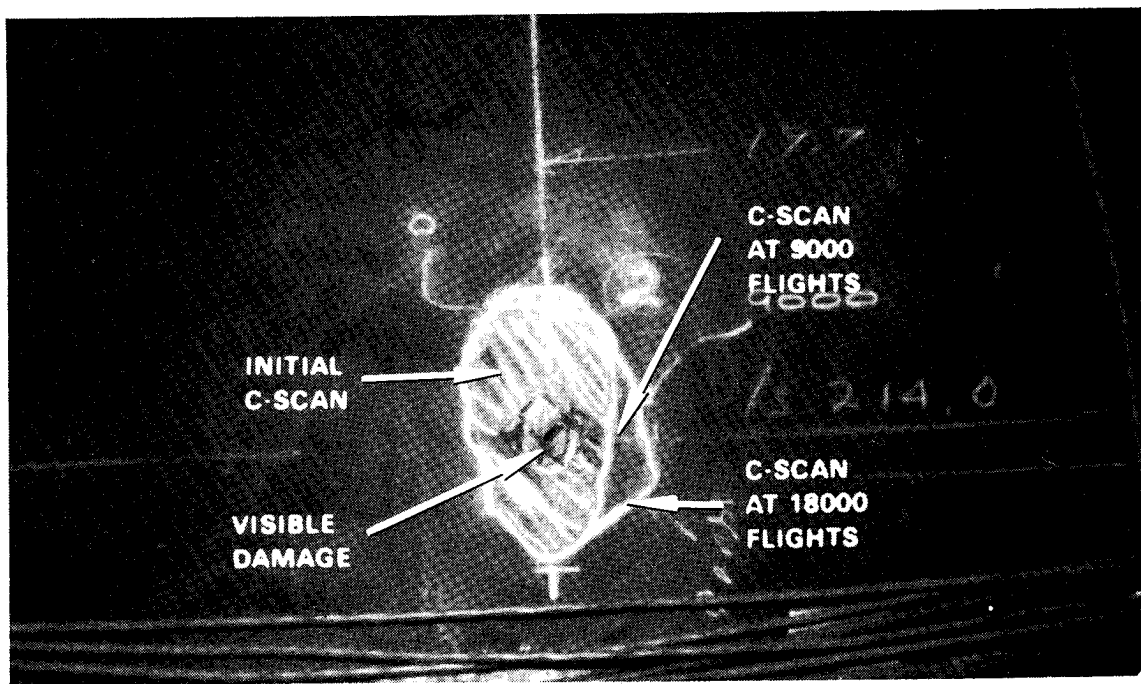
Figure 35. - Impact No. 2 damage growth.

At the completion of each one-quarter lifetime (9000 flights) of fatigue loading the impacted areas were inspected ultrasonically and damage growth, if any, marked on the part. The damage and growth for impact No. 2 shown in figure 35 is typical of that which occurred at all five locations. Most growth occurred during the first half lifetime of fatigue cycling and could only be determined ultrasonically.

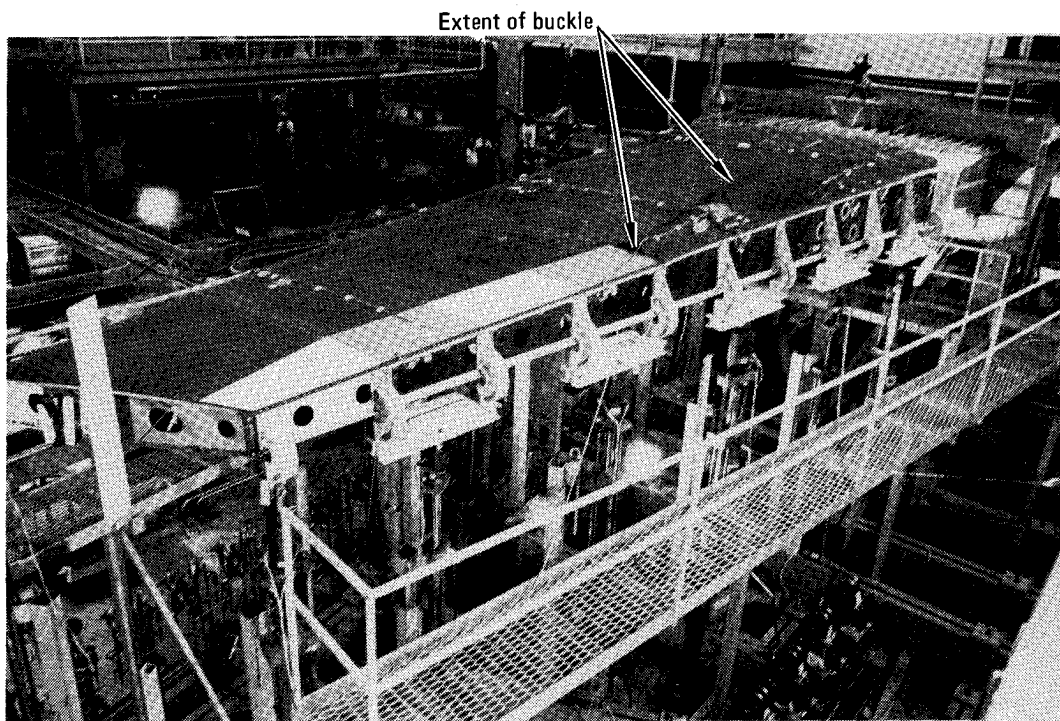
Figure 38. - Fin box at the moment of failure.

The initial failure was caused by high interlaminar stresses induced by shear buckling of the trapezoidal skin panel between VSS 222 and VSS 248 and between the front spar and stiffener No. 10. The high speed film showed that the skin buckled up just above VSS 222 and the buckle then propagated outboard and inboard as the skin and stiffener separated. Shear buckling was measured by a pair of back-to-back shear rosettes in the bay below VSS 222. The strain gage plots shown in figure 39 indicate that shear buckling initiated at about

design limit load. The Poisson-induced lateral compression strain combined with the shear caused the initial buckling and proved to be more severe than the axial compression and shear on the other cover which did not buckle until 80 percent DUL.
